0 200 688
A1

EUROPEAN PATENT APPLICATION

(54) Member for indicating clogging of the air intake filter, particularly for motor vehicle engines.

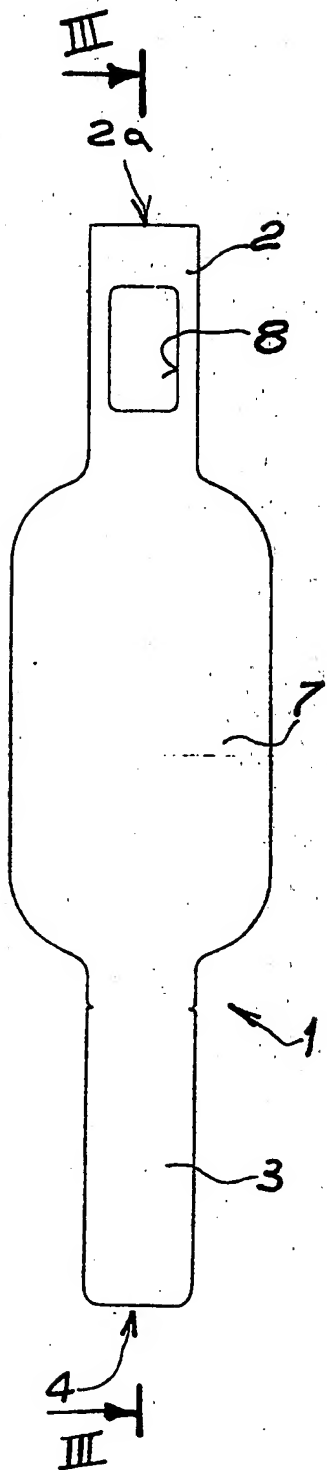
Fig. 1

Figure 1 is a plan view of the indicator member according to the
20 invention;

As can be seen from the figures, the indicator member according to the
30 invention consists of a duct 1 having an end portion 2 provided with an opening 2a to be located in communication with a zone external to the filter, and a tubular end portion 3 provided with an opening 4 communicating with the zone in which the air leaves the filter towards

A thin strip 6 of plastics material or the like is connected to this piston and extends through the intermediate portion 7 of the duct 1 as 10 far as the end portion 2. In proximity to the opening 2a of said end there is an aperture 8, through which the end part of the strip 6 can be seen.

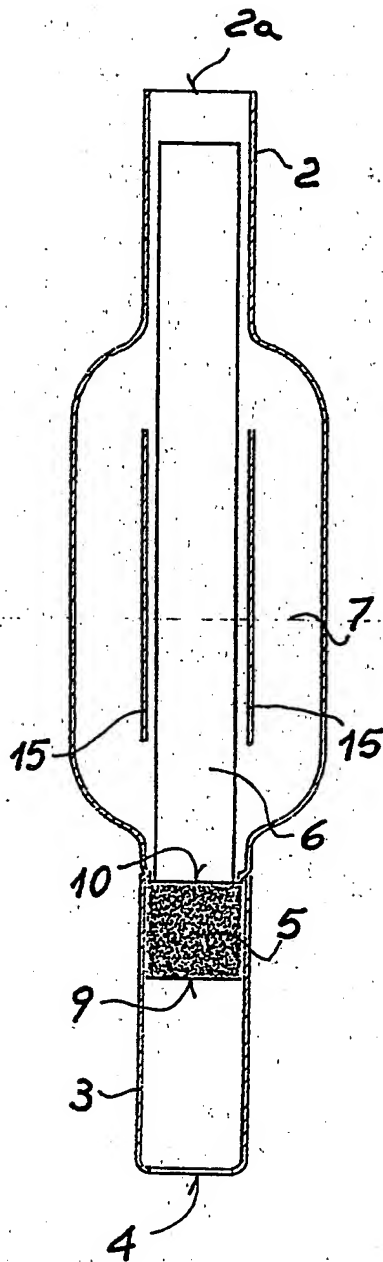
Fig. 2

Figure 2 shows the indicator member of Figure 1 without its upper part;

In the tubular end portion 3 there is disposed a piston 5 of light material such as expanded closed-cell material, which can slide within 5 the tubular portion 3 under the action of a slight pressure difference between the two parts of the tubular portion 3 separated by it.

Guide baffles 15 are conveniently provided in the intermediate portion 7 to help maintain the strip 6 aligned with the piston 5 connected to it, and to also provide rigidity to the portion 7 zone which is to be compressed for deforming said gaskets.

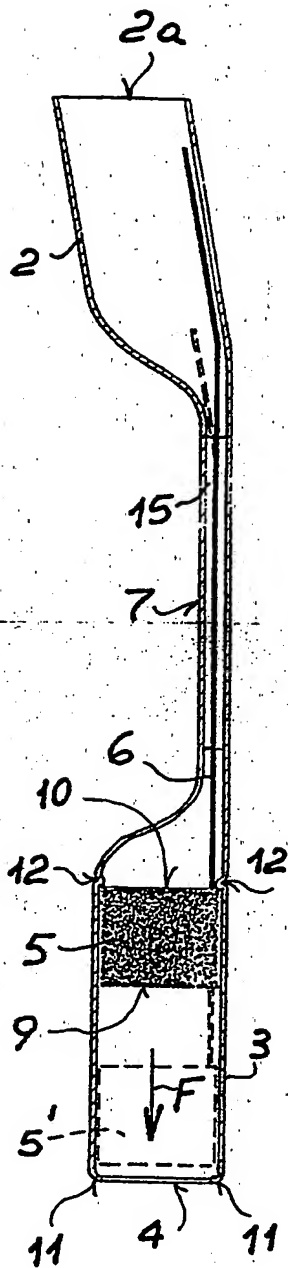
Fig. 3

Figure 3 is a section on the plane III-III of Figure 1; and
25

Under normal operating conditions, i.e. when the filter is clean, the 15 pressure drop which the air undergoes in passing through this latter is very small and does not therefore influence the position of the piston 5.

When the filter is clogged, the air drawn in by the engine undergoes a 20 large pressure drop in passing through the filter, and this results in a vacuum at the filter outlet in the direction of the engine. This vacuum also acts on the face 9 of the piston 5 which faces the end portion 3, whereas the pressure of the external environment acts on that face 10 of the piston which is in communication with the outside by way of the 25 intermediate portion 7 and the end portion 2 of the duct 1. Under these conditions, the piston thus moves in the direction indicated by the arrow F of Figure 3 to the position indicated by 5', in contact with the rim 11 at the opening 4 of the tubular end portion 3. The strip 6 is therefore no longer visible through the aperture 8, and this therefore 30 signals that the filter is clogged and requires replacement or cleaning.

When the filter has been replaced or cleaned, the piston 5 can be again moved into its initial position, indicated by the stop projections 12

provided internally on the end portion 3 in the position in which the end of the strip 6 is visible through the aperture 8.
